**DuBOIS CREEK DAM**

NDI No. PA 00064  
PennDER NO. 58-8  
Dam Owner: Keystone Water Company

**PHASE I INSPECTION REPORT**  
**NATIONAL DAM INSPECTION PROGRAM**

DuBois Creek Dam, Susquehanna County, Pennsylvania  
NDI No. PA 00064, PennDER No. 58-8  
DuBois Creek  
Inspected 28 October 1980

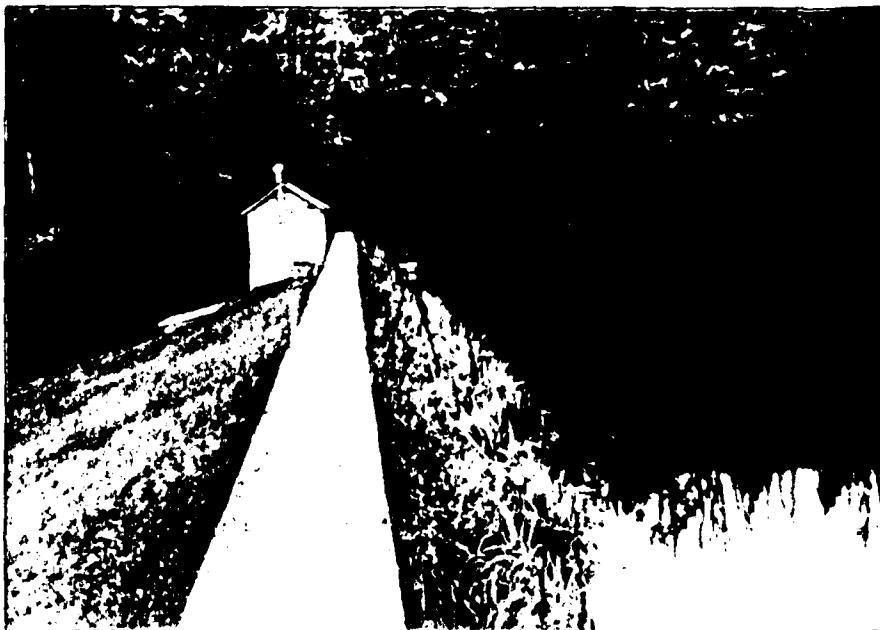
PHOTO 8. View Along Crest of Dam from Right Training Wall of Spillway

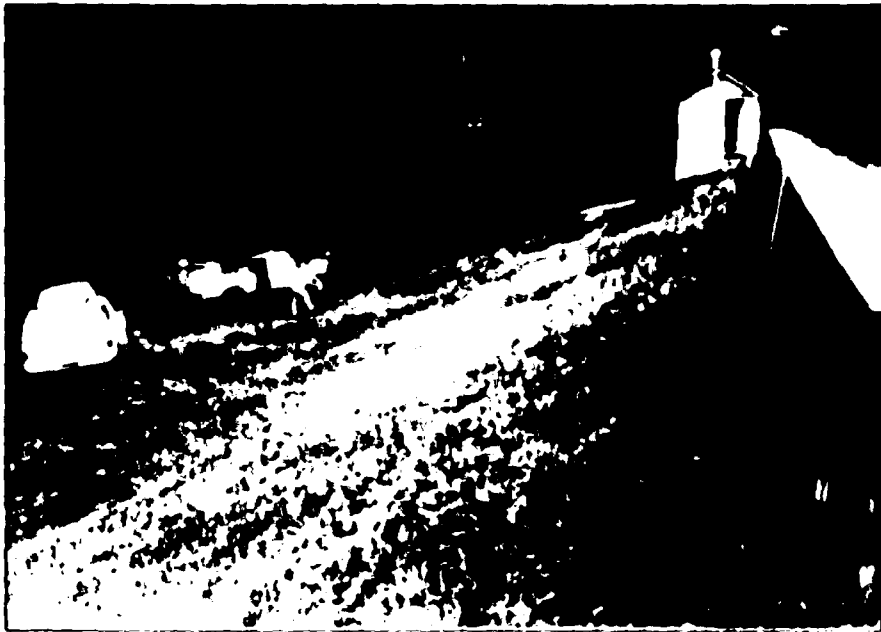
SLOUGHING OR EROSION OF EMBANKMENT AND ABUTMENT SLOPES	Downstream slope is slightly irregular, probably the result of erosion caused by seepage through the core wall.	Fill in erosion gullies and reseed.
--	---	--

PHOTO 9 View of Downstream Face of Dam from Right Training Wall of Spillway

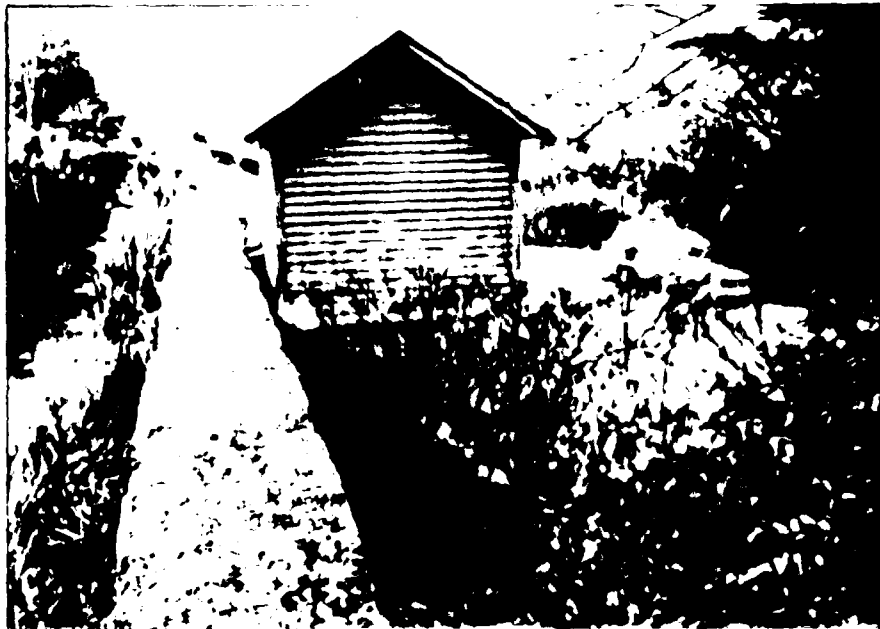
PHOTO 10 View Along Crest of Dam from Right Abutment

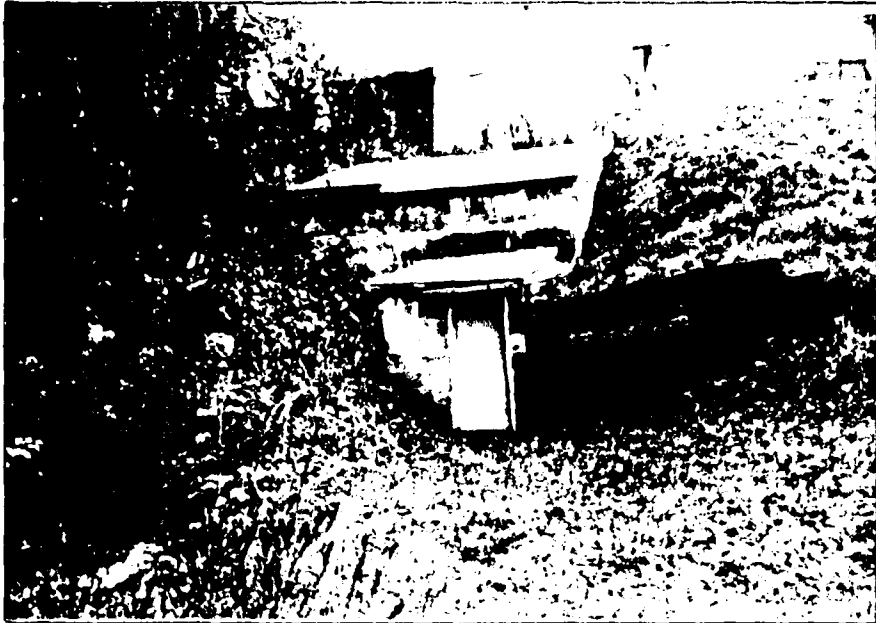
PHOTO 15. View of Outlet Conduit Valve Structure from Downstream
